EXTREME TEST

ICF structures blasted with TNT to demonstrate safety, strength

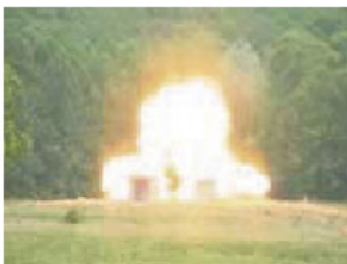
Day 2 explosion

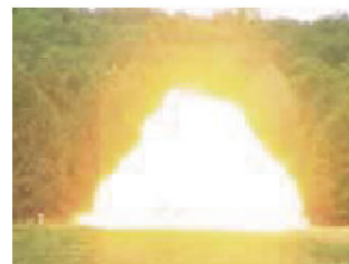
Day 3 explosion

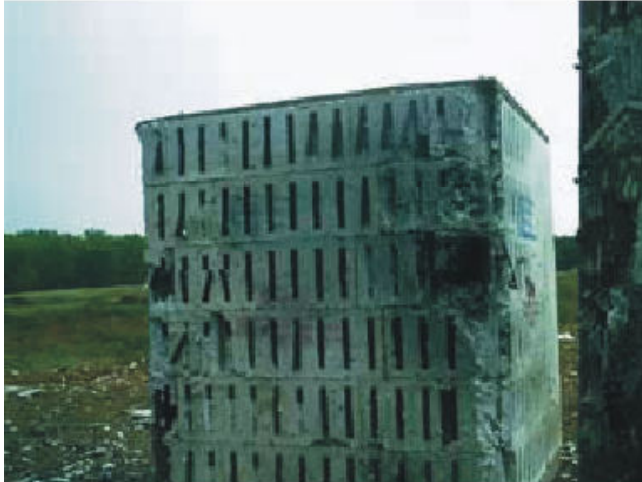
Structures suffered only singeing

On the closest blast at 6 feet, the 50-pound charge of TNT generated lateral forces well in excess of 10 times the weight of the box and created a ball of fire approximately 200 feet wide and 100 feet tall. Even at 6 feet, the blast resulted in nothing more serious than some small cracks on the face of the wall (cracks less than 2 millimeters wide) and some singeing of the EPS. There was no structural damage, no deflection and no concrete spall. The EPS was singed, a result of the close proximity of the ICF reaction boxes to the fireball created by the explosion.
